Permit #	Deficiency ExteNet Must Correct	Public Works Inspection Photograph	ExteNet Simulation	ExteNet Plans
1680 Powell St. / 14WR-0017	A disconnect switch was installed that is larger than the switch approved in the plans/sims			
826 Vallejo St. / 14WR-0026	A disconnect switch was installed that is larger than the switch approved in the plans/sims

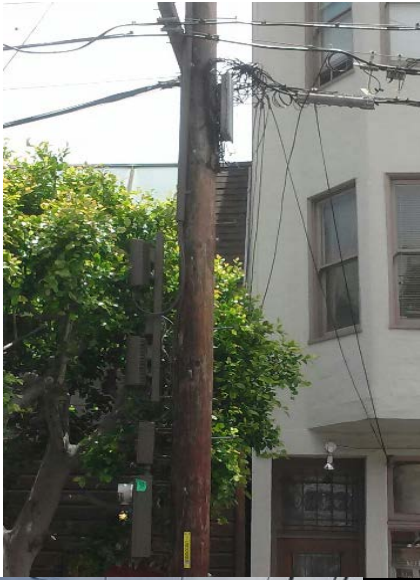
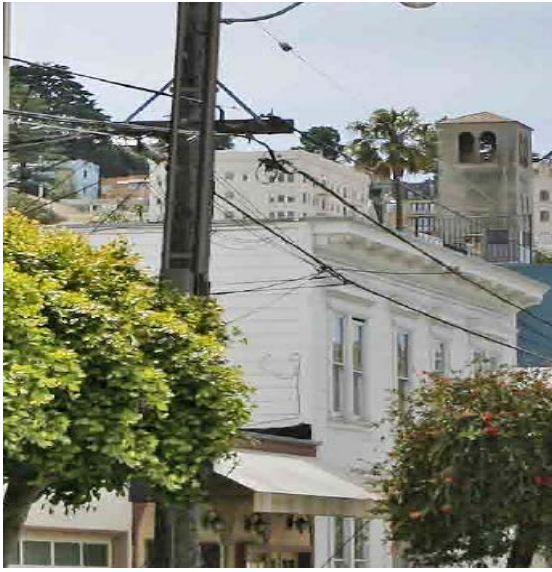
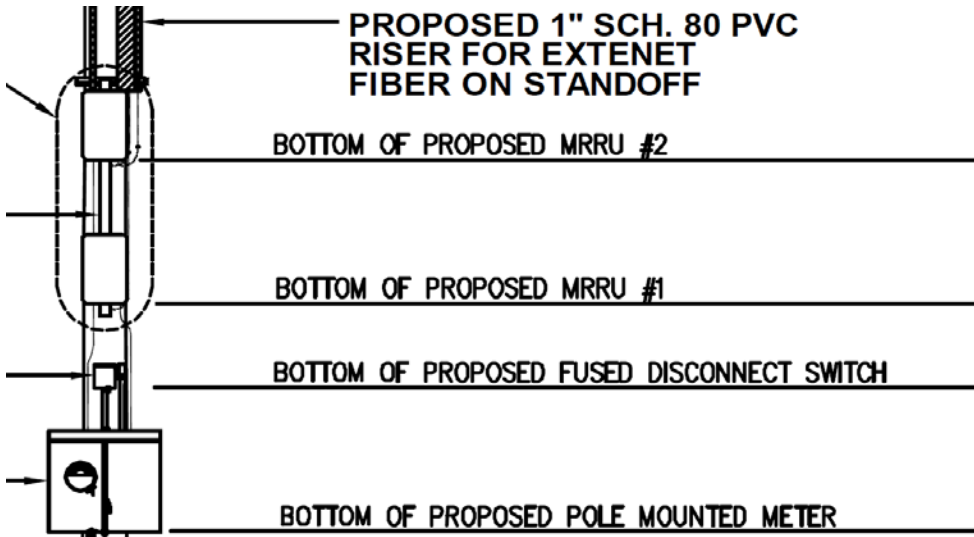
539 Francisco St. / 14WR-0034	A disconnect switch was installed that is larger than the switch approved in the plans/sims

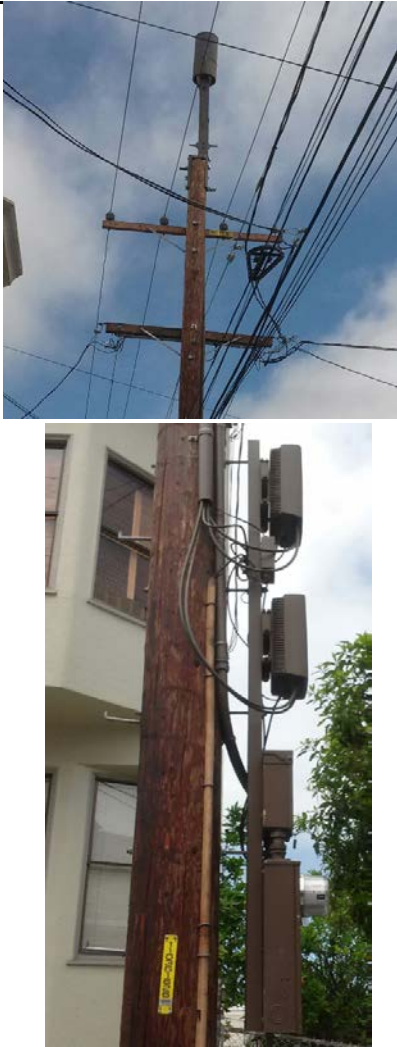
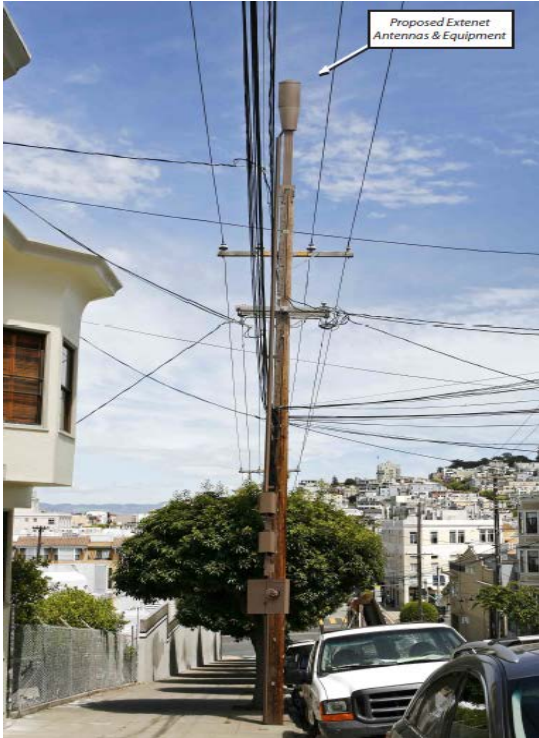
Permit #	Deficiency ExteNet Must Correct	Public Works Inspection Photograph	ExteNet Simulation	ExteNet Plans
759 Chestnut St. /14WR-0039	<p>The plans and sims indicate that the antenna should have been centered on the pole. However, the antenna was not centered and a large bolt is visible at the base of the antenna that was not shown in the plans and sims. Additionally, the installed antenna looks like a different model than what was shown on the plans and sims. Moreover, it appears that the MRRU, disconnect switch, and meter are installed on the eastern side of the pole, but the sims and plans indicate this equipment was proposed on the western side of the pole. Furthermore, a disconnect switch was installed that is larger than the switch approved in the plans/sims. [Regarding the inspector's comments, the permit was approved with a vertical antenna; the previous design was a horizontal antenna.]</p>

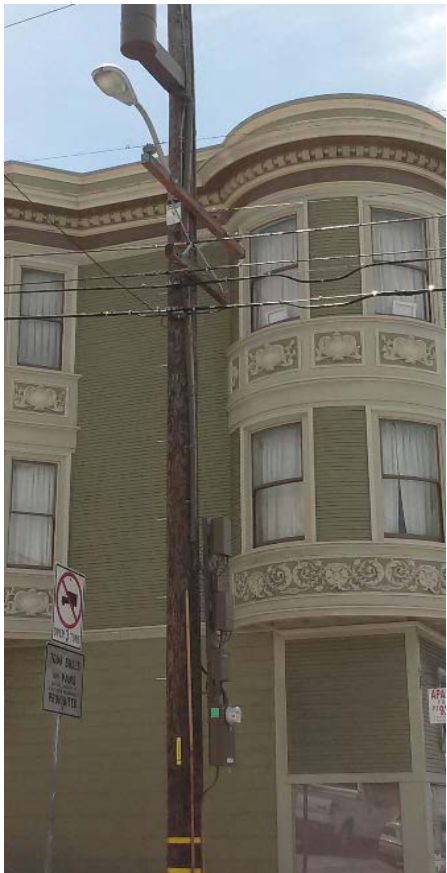
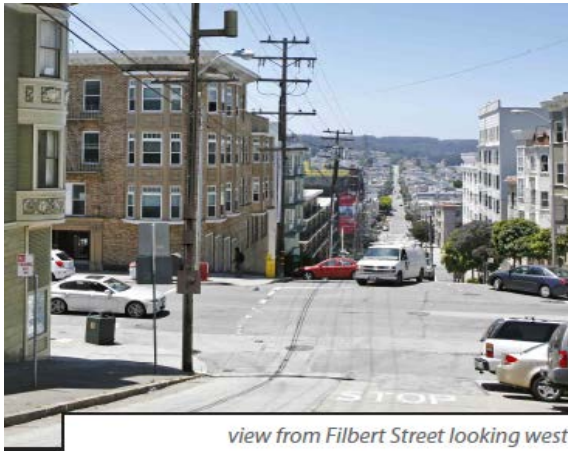
2460 Polk St. / 14WR-0042	<p>Per plans and sims, the MRRUs, disconnect switch, and meter were supposed to be installed on the eastern side of pole. However, they were all installed on the western side of the pole. Additionally, a disconnect switch was installed that is larger than the switch approved in the plans/sims</p>

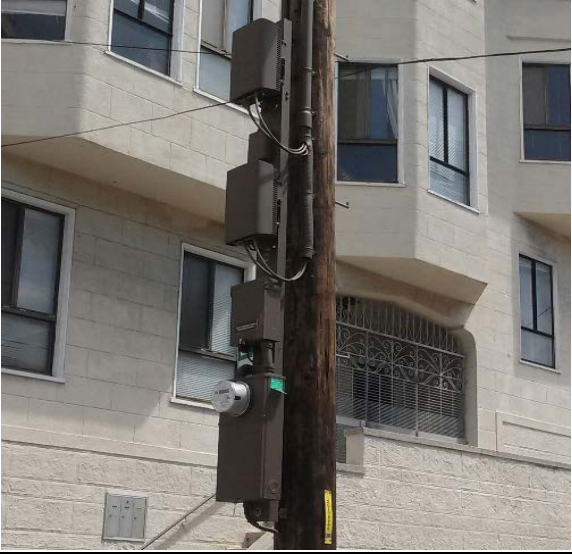
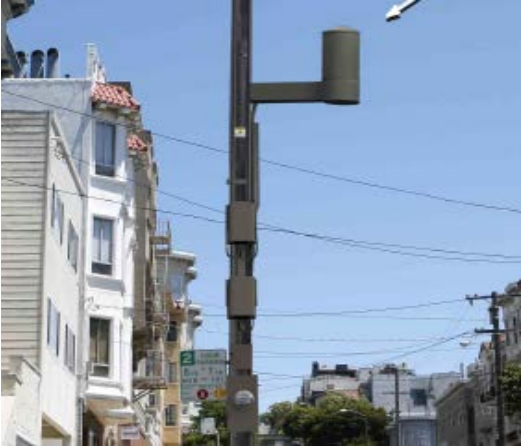
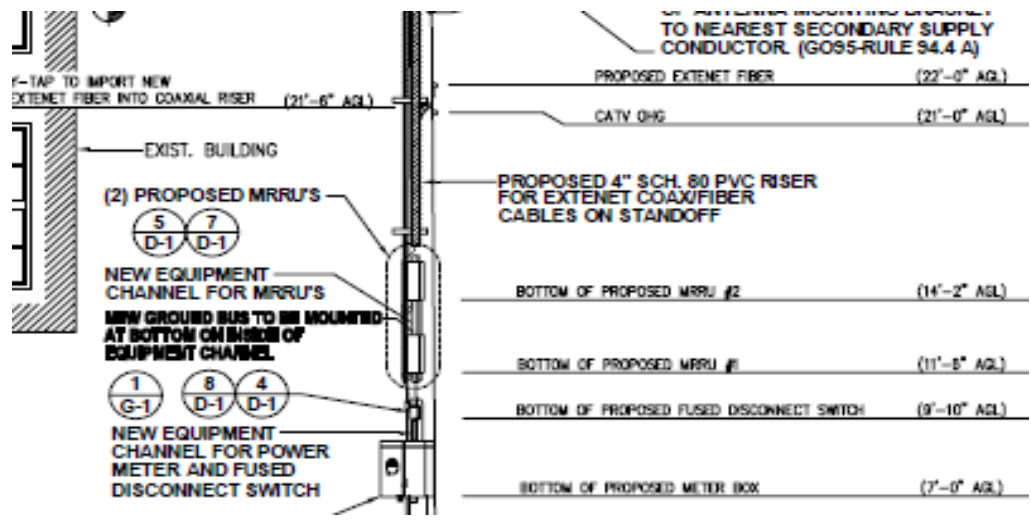
Permit #	Deficiency ExteNet Must Correct	Public Works Inspection Photograph	ExteNet Simulation	ExteNet Plans
1294 Vallejo St. / 14WR-0044	A disconnect switch was installed that is larger than the switch approved in the plans/sims

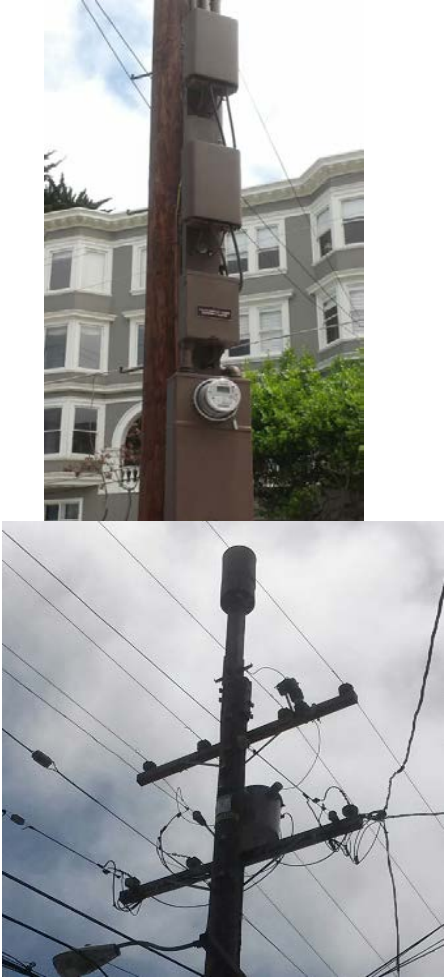
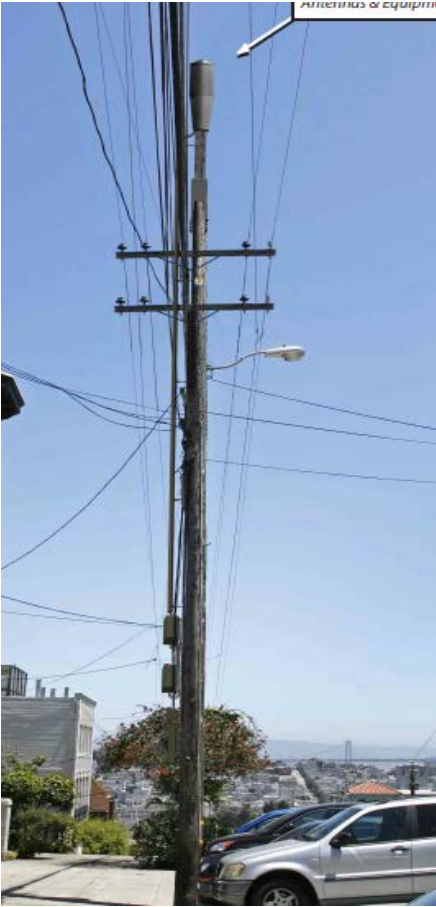
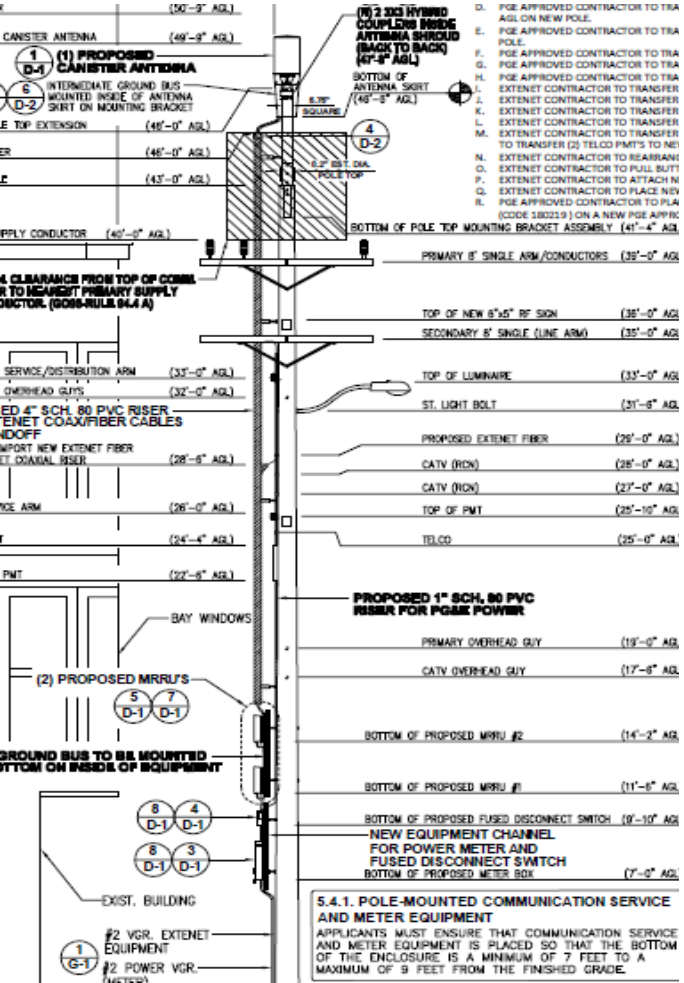
1154 Filbert St. / 14WR-0050	A large bolt is visible at the base of the antenna that was not shown in the plans and sims. Additionally, the installed antenna looks like a different model than what was shown on the plans and sims. Furthermore, a disconnect switch was installed that is larger than the switch approved in the plans/sims

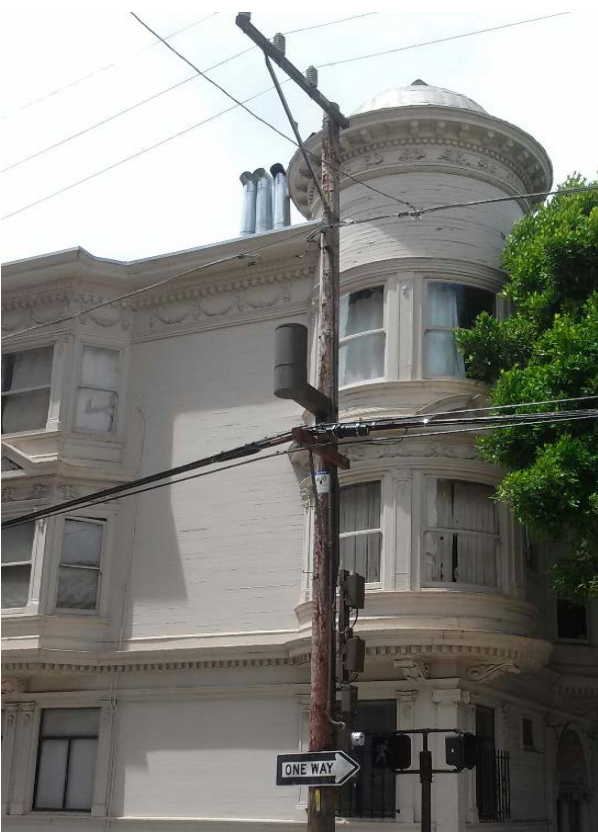
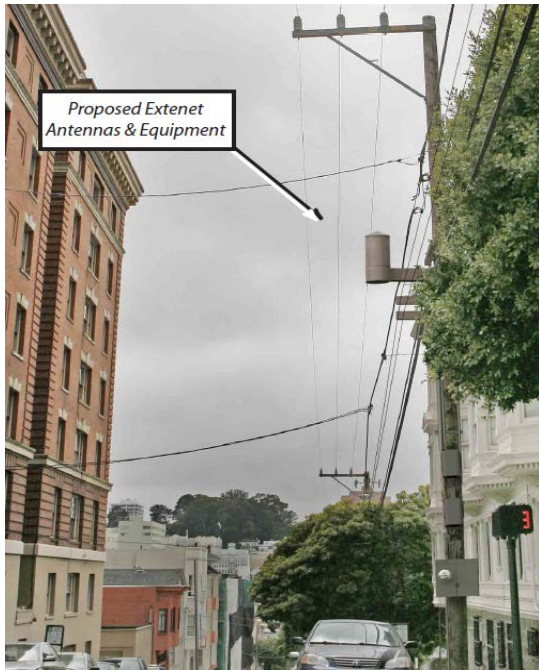
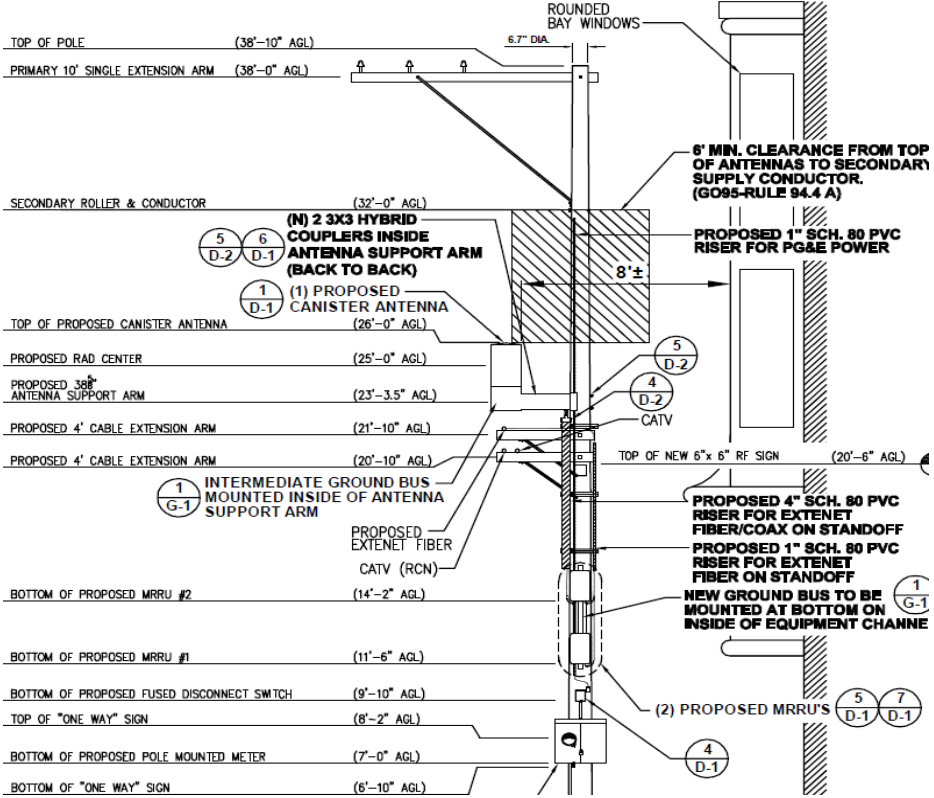
Permit #	Deficiency ExteNet Must Correct	Public Works Inspection Photograph	ExteNet Simulation	ExteNet Plans
1590 Washington St. / 14WR-0056	A disconnect switch was installed that is larger than the switch approved in the plans/sims. Additionally, the sims and plans indicate the pole would have 3 arms after construction. However, the pole only has 2 arms.

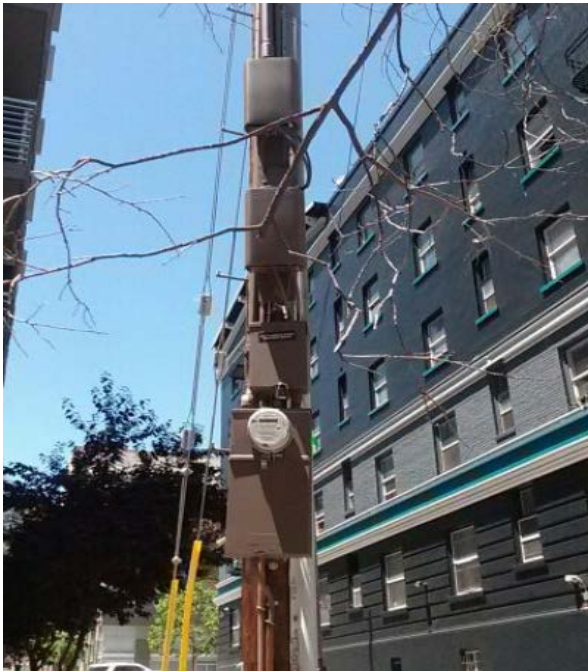
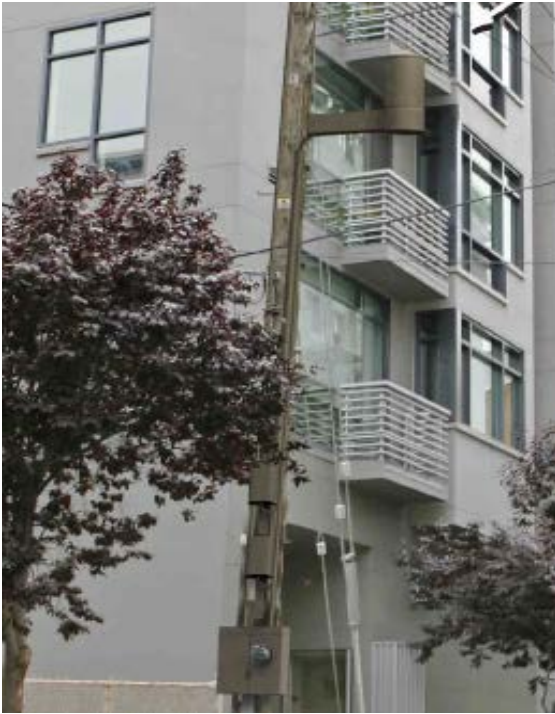
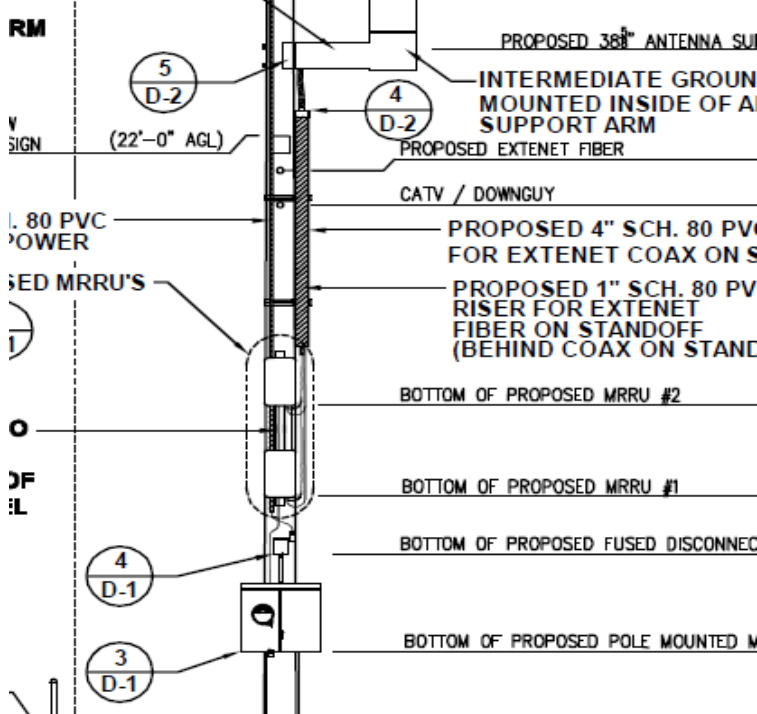
169 Willow St. / 14WR-0063	A disconnect switch was installed that is larger than the switch approved in the plans/sims

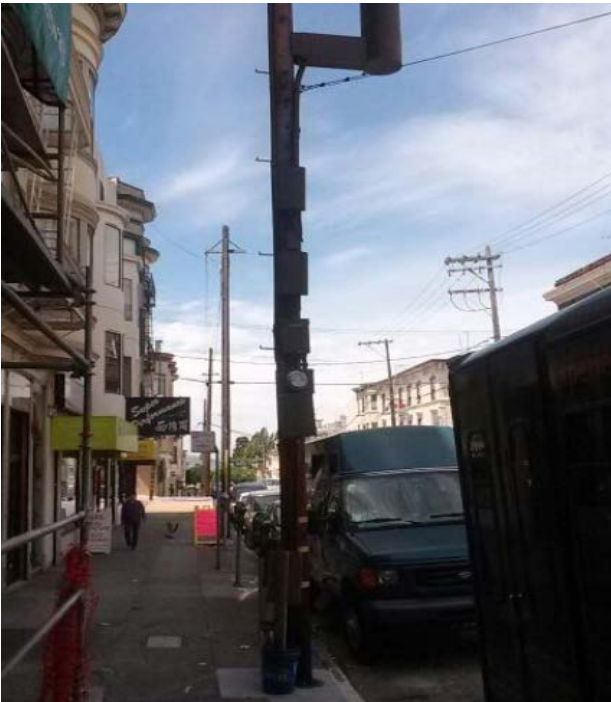
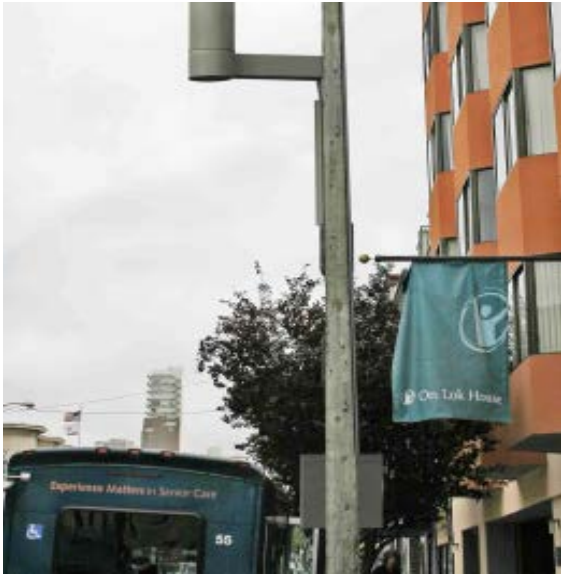
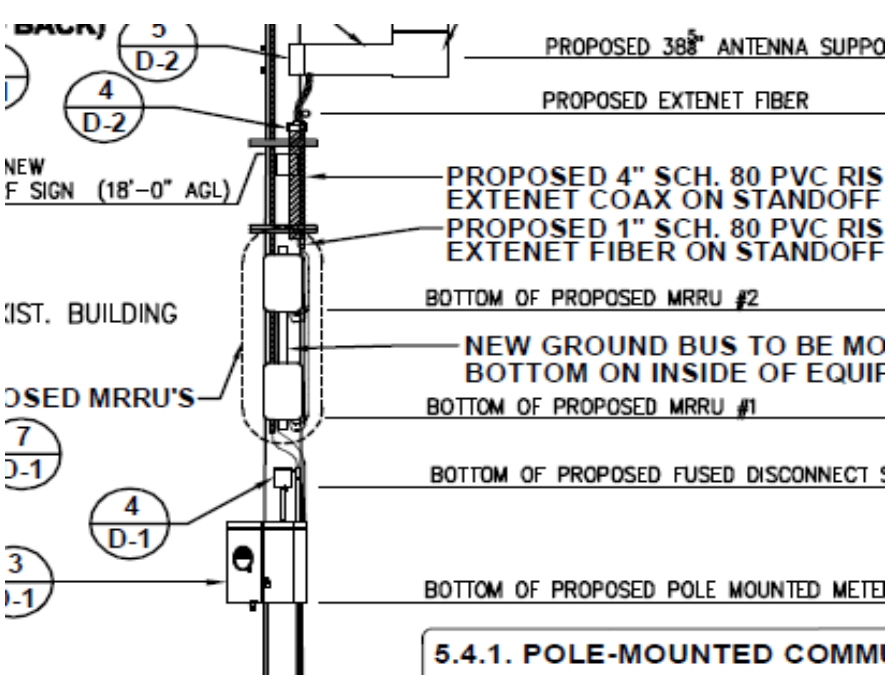
Permit #	Deficiency ExteNet Must Correct	Public Works Inspection Photograph	ExteNet Simulation	ExteNet Plans
1447 Powell St. / 14WR-0065	A disconnect switch was installed that is larger than the switch approved in the plans/sims

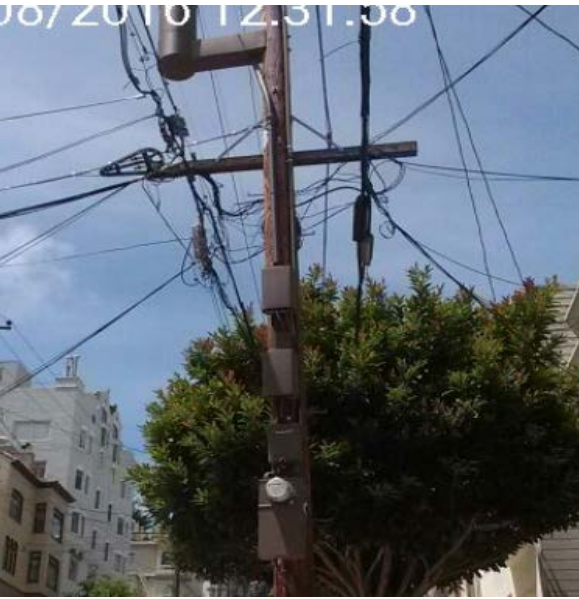
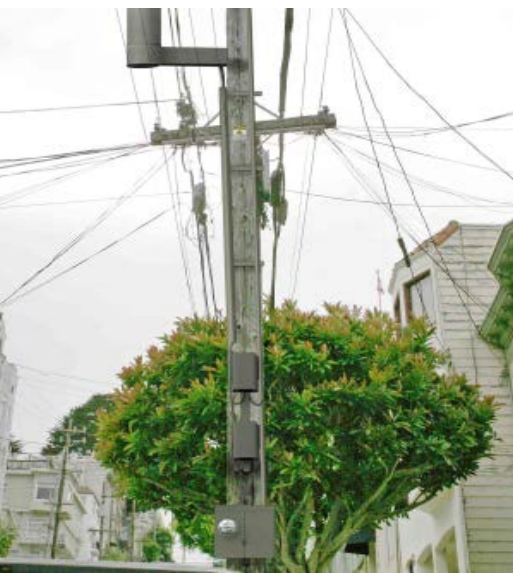
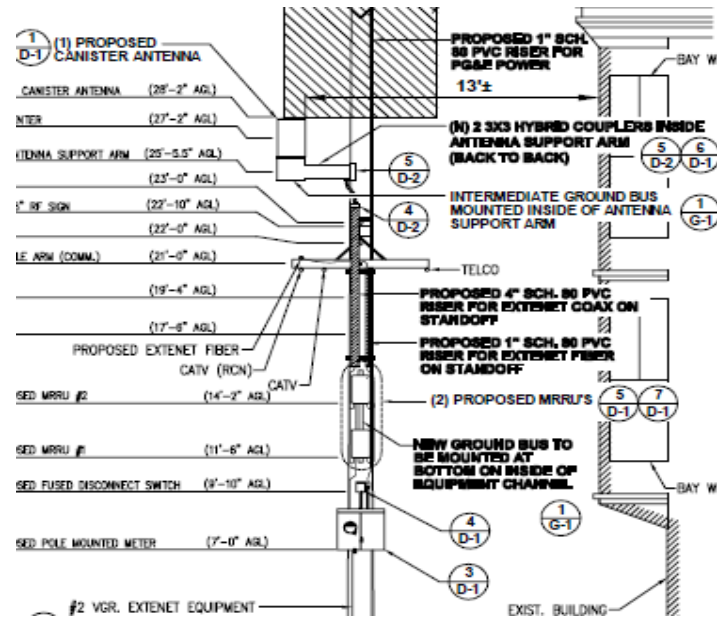
1050 Filbert St. / 14WR-0069:	A disconnect switch was installed that is larger than the switch approved in the plans/sims

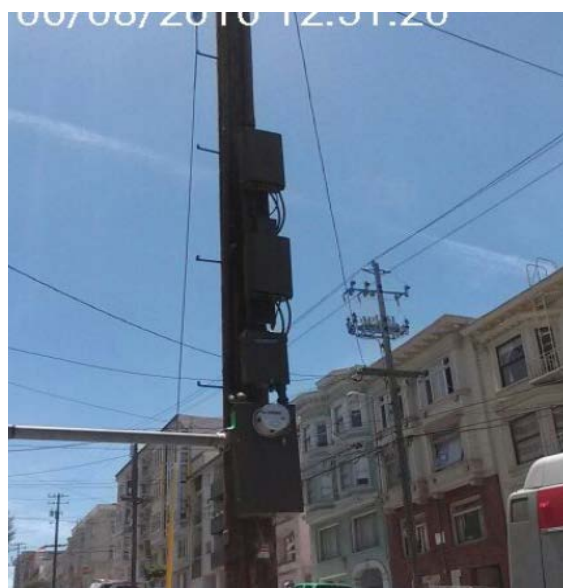
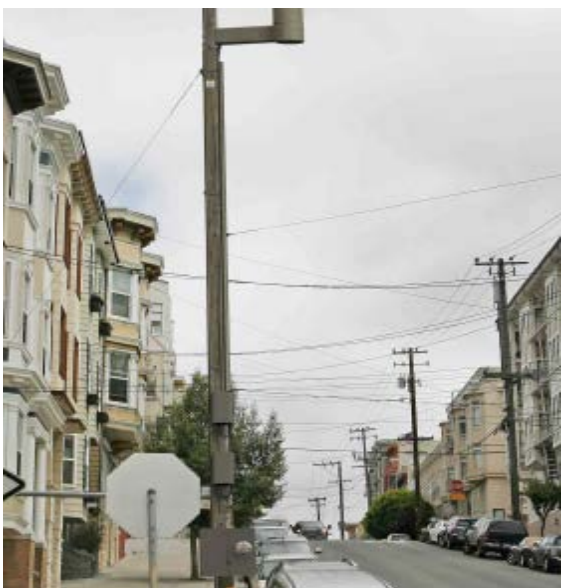
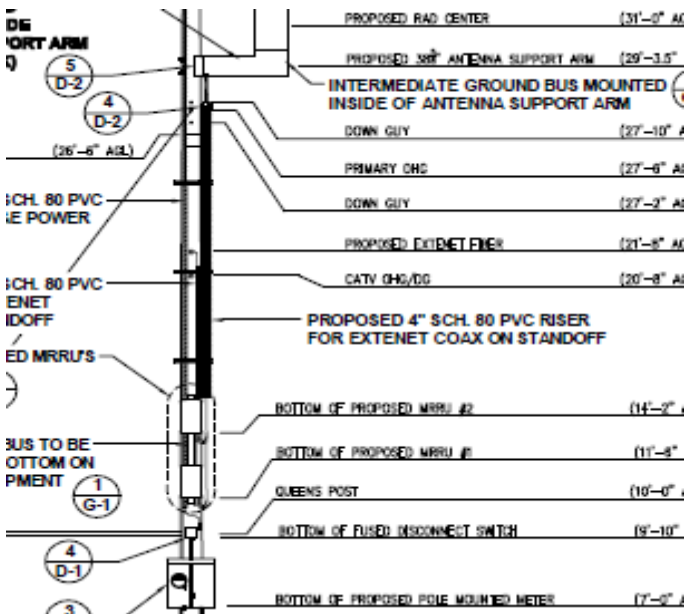
1456 Leavenworth St. / 14WR-0071	A disconnect switch was installed that is larger than the switch approved in the plans/sims

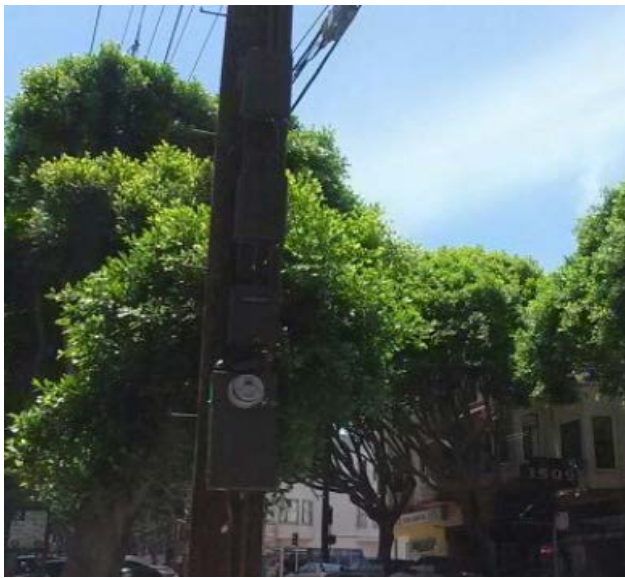
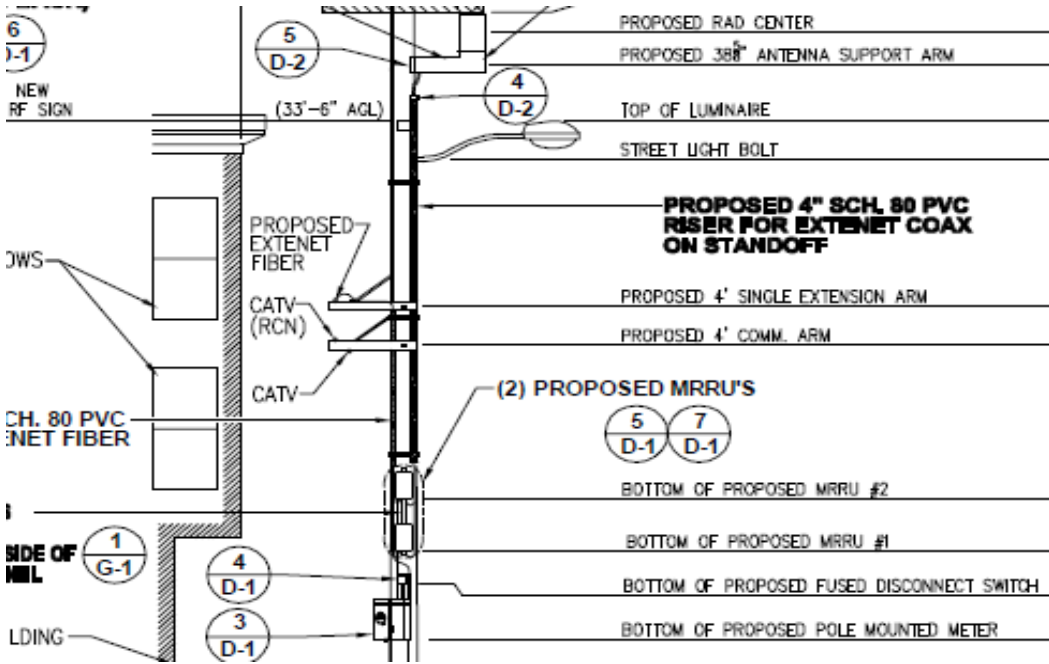
Permit #	Deficiency ExteNet Must Correct	Public Works Inspection Photograph	ExteNet Simulation	ExteNet Plans
1516 Hyde St. / 14WR-0078	A disconnect switch was installed that is larger than the switch approved in the plans/sims

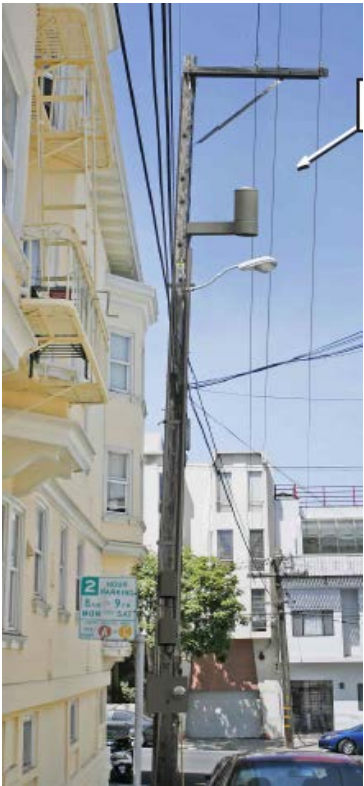
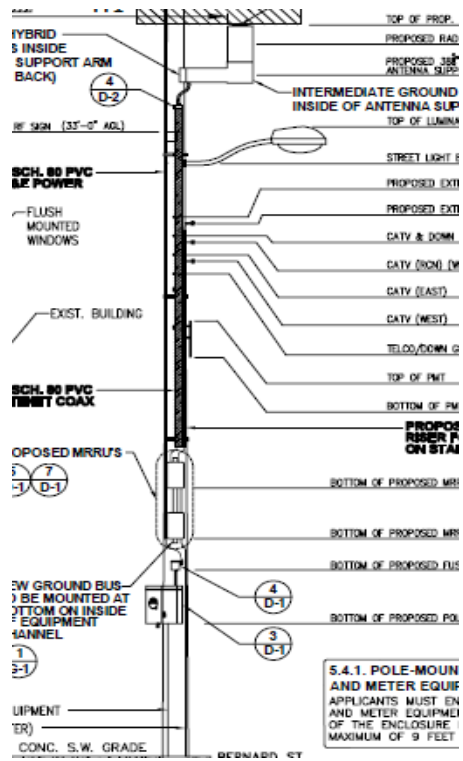
1620-24 Leavenworth St. / 14WR-0096	A disconnect switch was installed that is larger than the switch approved in the plans/sims

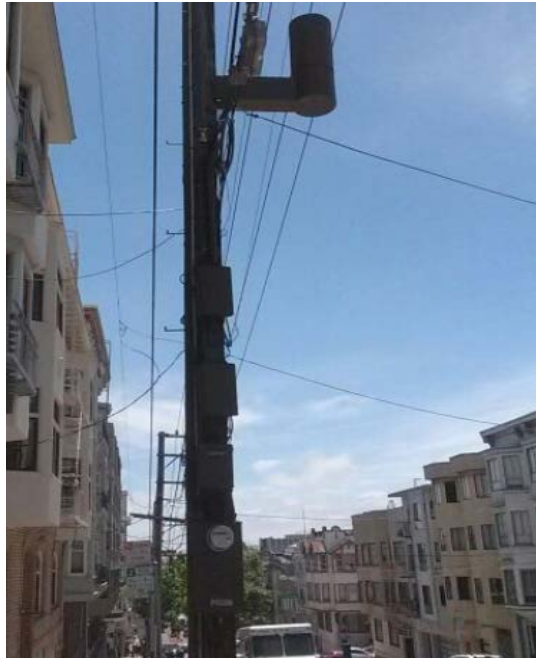
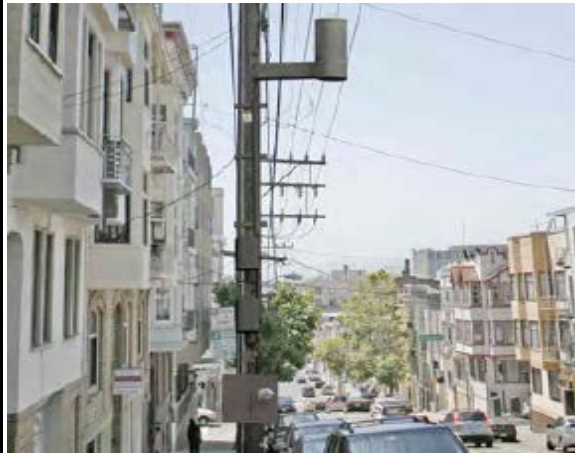
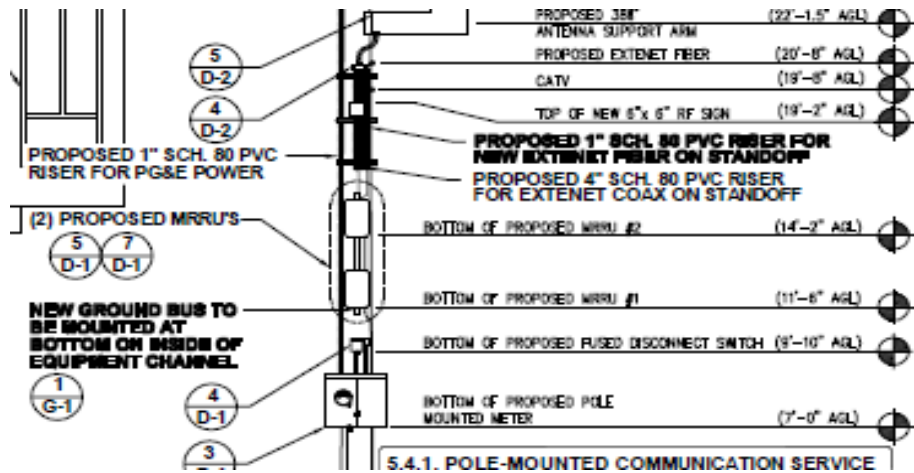
Permit #	Deficiency ExteNet Must Correct	Public Works Inspection Photograph	ExteNet Simulation	ExteNet Plans
1250 Hyde St. / 14WR-0101	A disconnect switch was installed that is larger than the switch approved in the plans/sims

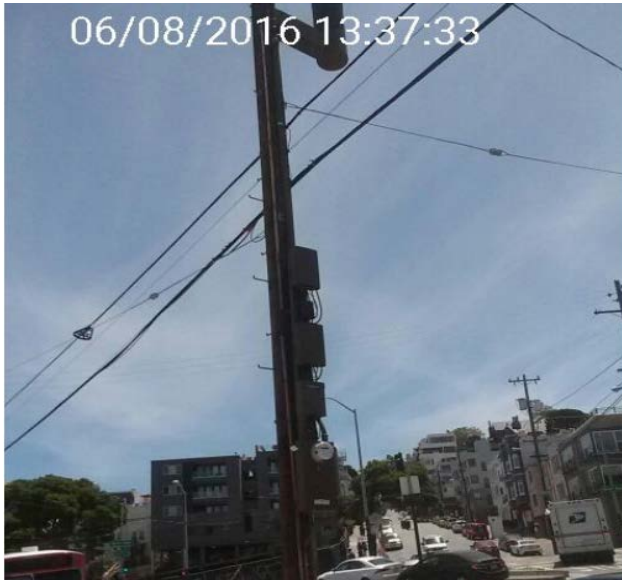
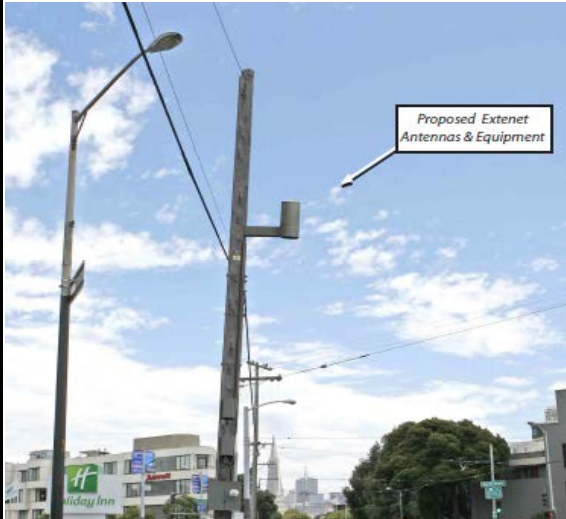
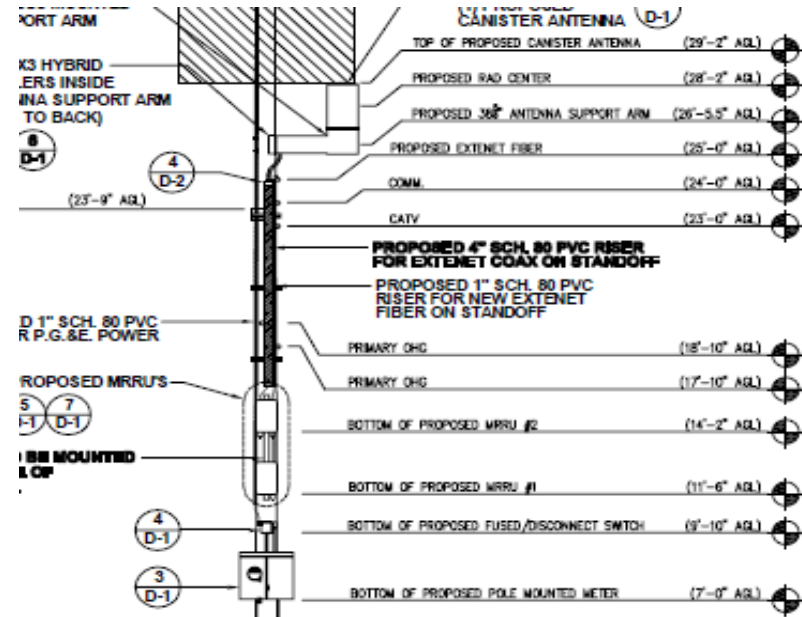
1348 Columbus. / 14WR-0104	A disconnect switch was installed that is larger than the switch approved in the plans/sims

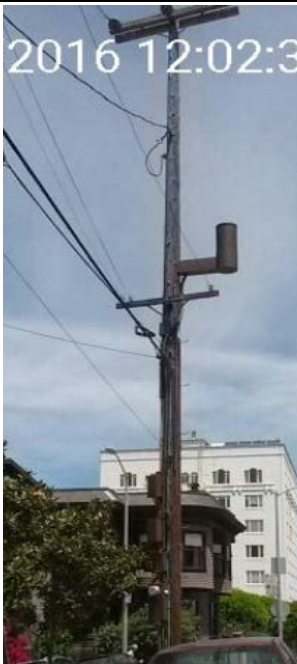
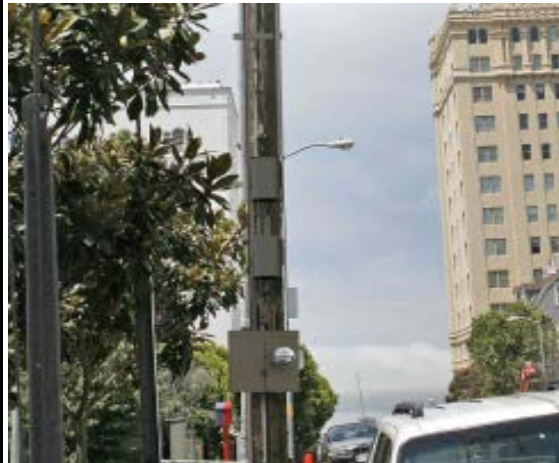
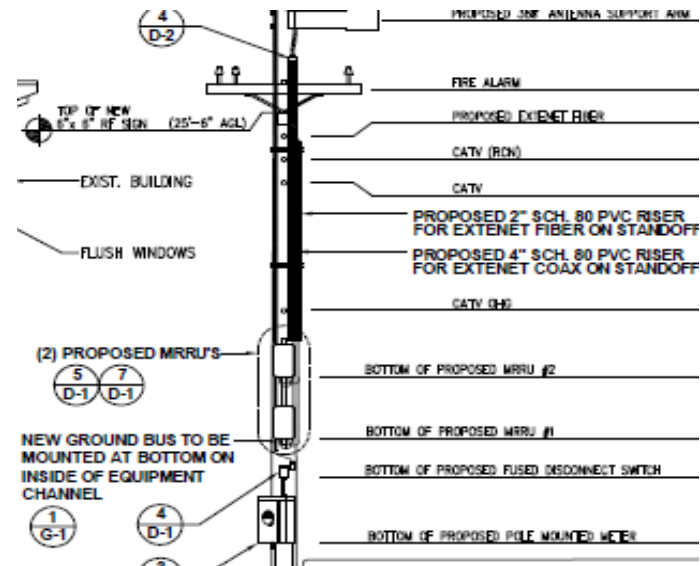
2565 Larkin St. / 14WR-0112	A disconnect switch was installed that is larger than the switch approved in the plans/sims

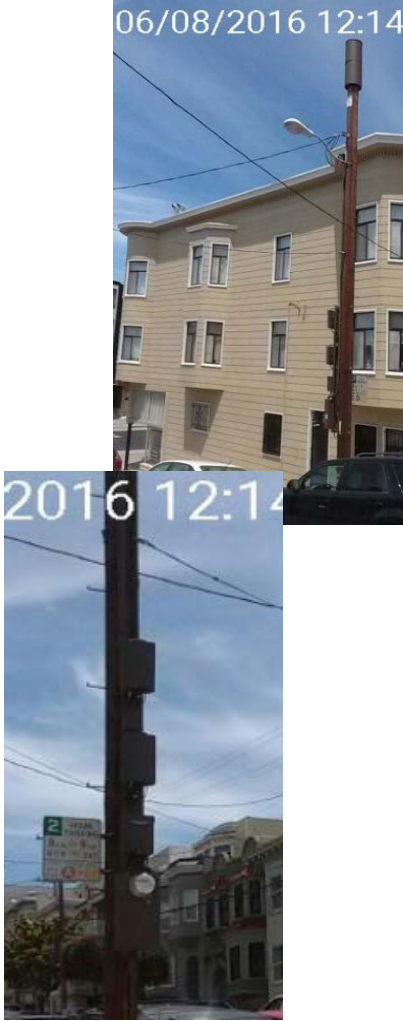
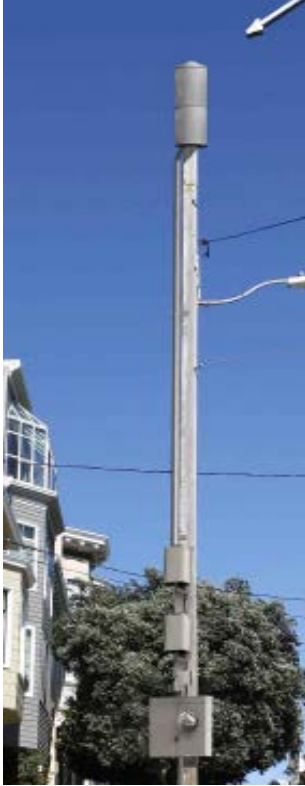
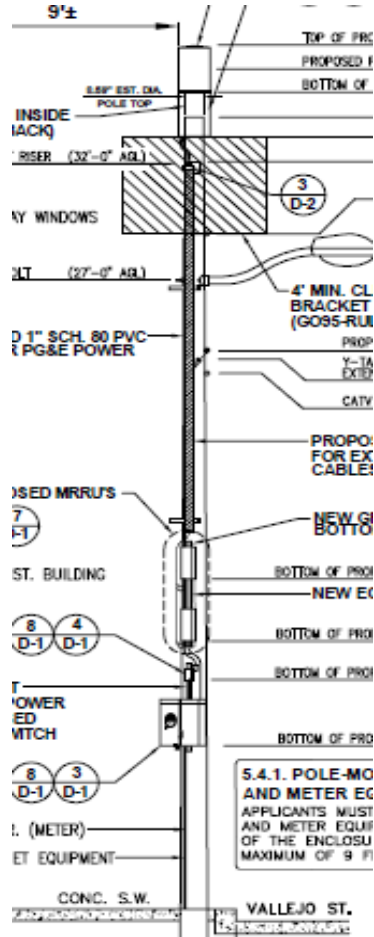
Permit #	Deficiency ExteNet Must Correct	Public Works Inspection Photograph	ExteNet Simulation	ExteNet Plans
1379 Vallejo St. / 14WR-0115	A disconnect switch was installed that is larger than the switch approved in the plans/sims

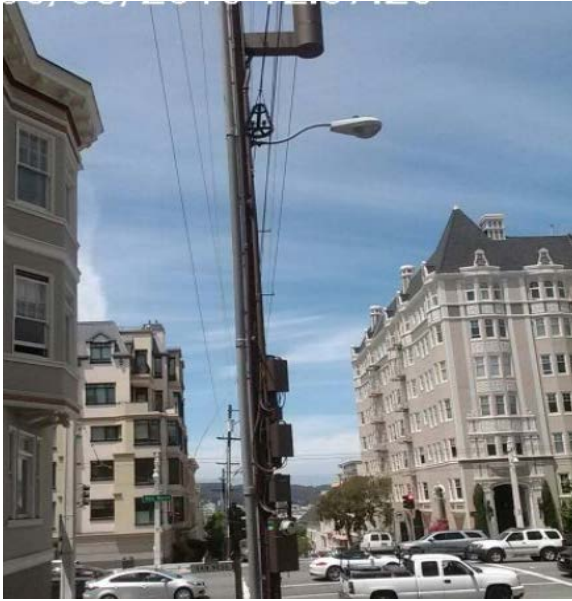
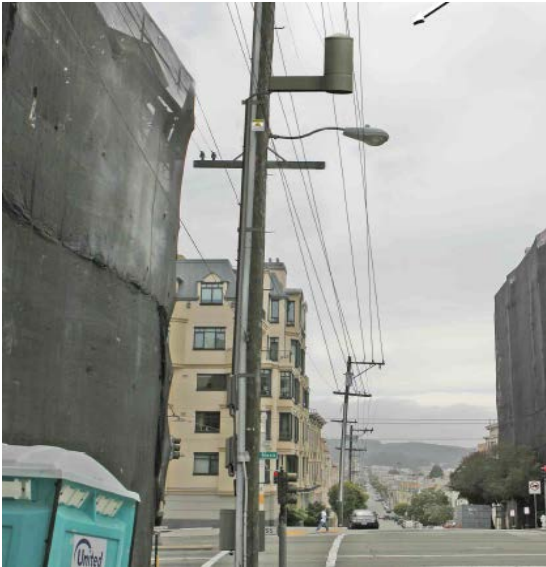
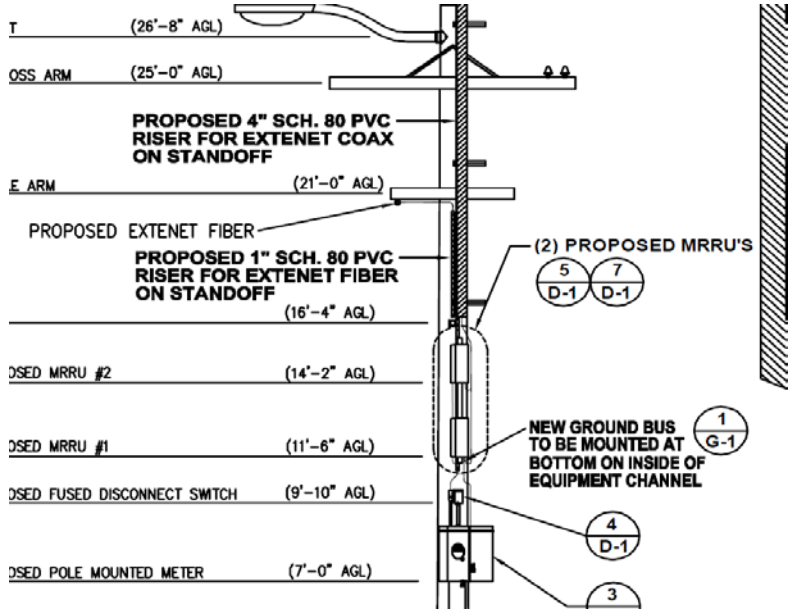
1487 Greenwich St. / 14WR-0120	Per plans and sims, it appears that the MRRUs, meter, and disconnect switch were proposed to be installed on the southwestern side of the pole, but they were installed on the northeast side of the pole. It also appears that a disconnect switch was installed that is larger than the switch approved in the plans/sims.

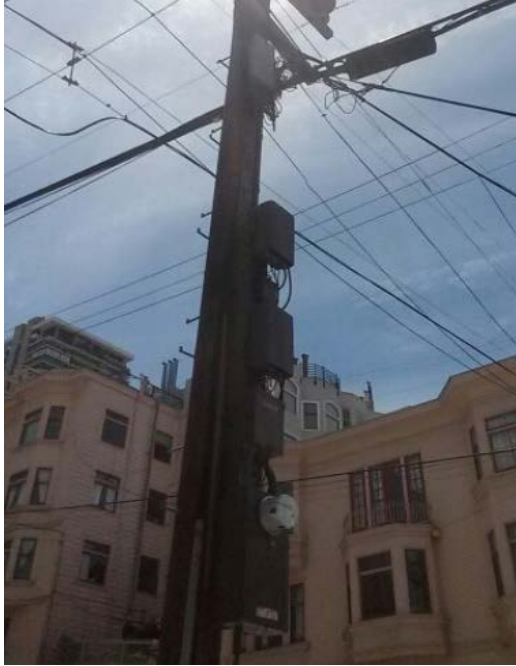
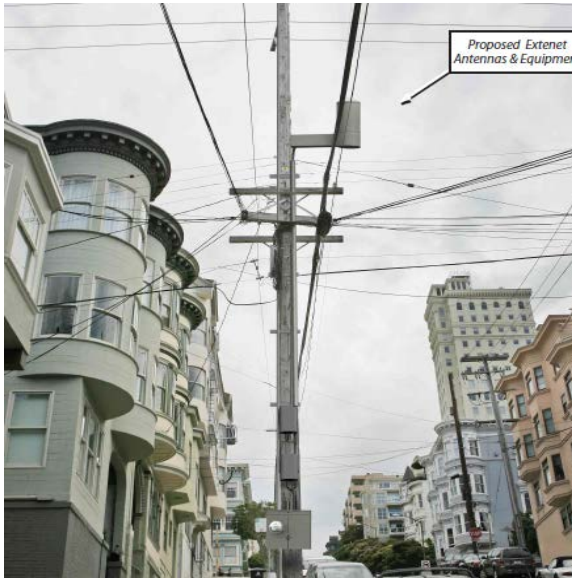
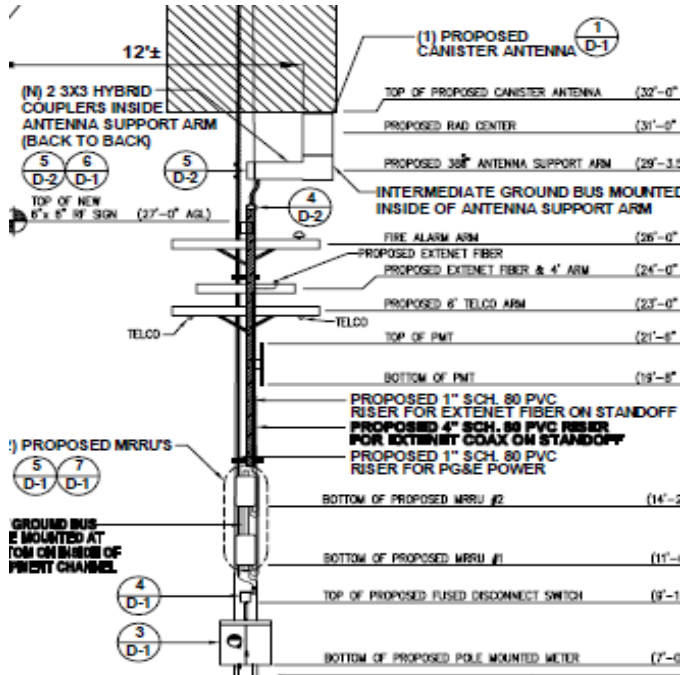
Permit #	Deficiency ExteNet Must Correct	Public Works Inspection Photograph	ExteNet Simulation	ExteNet Plans
1932 Taylor St. Also 99 Aladdin Ter., / 14WR-0123	A disconnect switch was installed that is larger than the switch approved in the plans/sims

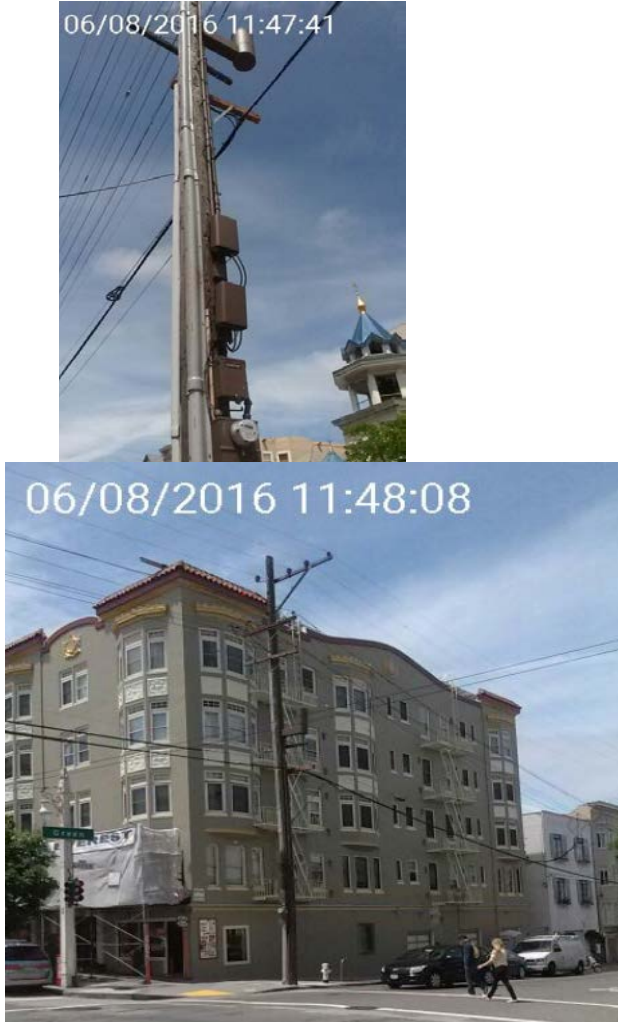
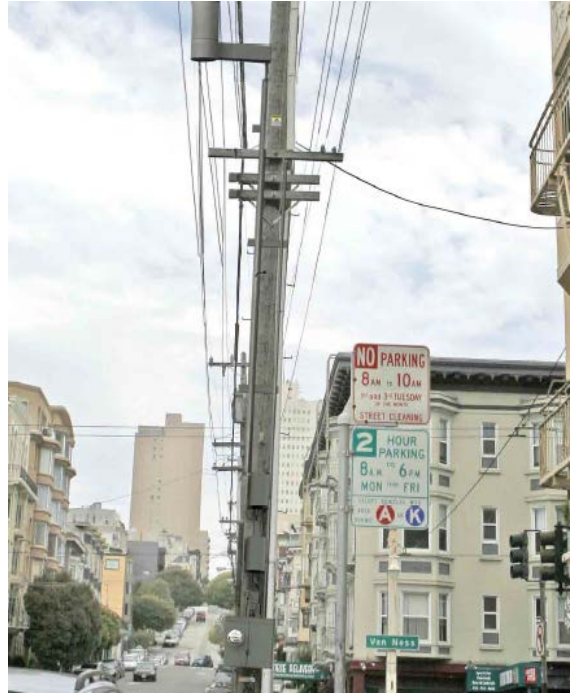
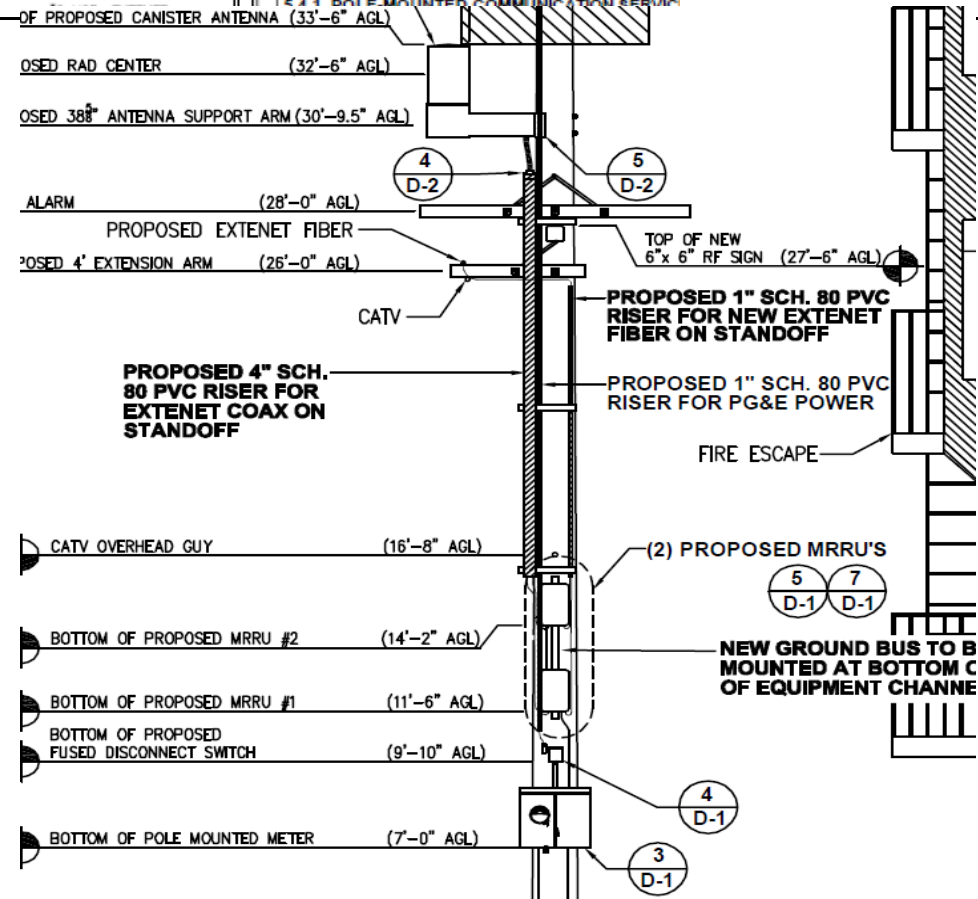
2363 Van Ness Ave. / 14WR-0124	Per plans and sims, the MRRUs, disconnect switch, and meter were supposed to be installed on the western side of pole. However, they were all installed on the eastern side of the pole. Additionally, A disconnect switch was installed that is larger than the switch approved in the plans/sims.
